**Flood Control Project Maintenance
Levee Inspections**

Maintenance Issue Types Only, Levee Inspection Report By Mile - Fall 2018

Reclamation District No. 2035 Conaway

Waterway	Bank	Unit Miles	Inspection Start/End	Inspector
Unit No. 01 Cache Creek Settling Basin	Right	2.01	09/14/2018 09/14/2018	Zach Jojola

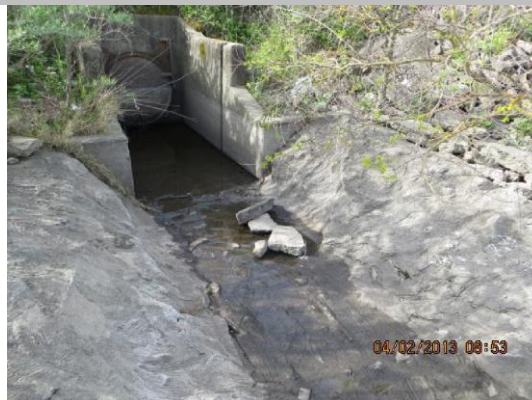
Photo 2 of 3 : UCIP_FA_2018_10827_18108.jpg

Flap gate and spillway on WS toe.

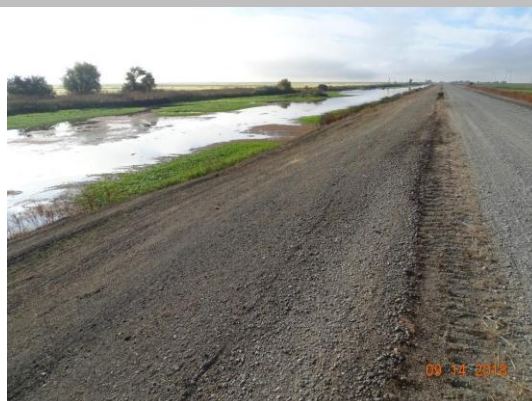
Photo 1 of 1 : FA_2018_RD2035_239_18_20180914_00028.jpg

LM Start	0.41	Rating **	A	Issue No.	18
LM End	0.41	Issue Type +	Ma	Location *	WS
Category	Earthen Levee			GPS Latitude/Longitude	
				Start	End
Item	Vegetation			38.671324 °	38.671324 °
				-121.671466 °	-121.671466 °
DWR ID	DWR_RD2035_02_f_2018_18				
Comment Code					
V1 : Control annual grass and weeds on the levee slopes and easements.					
Inspector Comment					
RD 2035 maintains the vegetation at a high level.

View of the burned and dragged waterside slope, facing downstream.
Fall 2018.

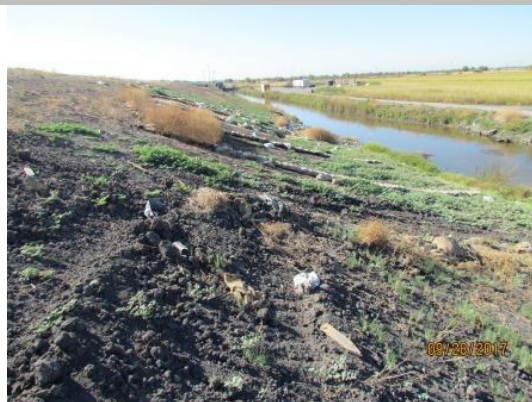
Photo 1 of 4 : FA_2018_RD2035_239_31_20180904_00002.jpg

LM Start	6.35	Rating **	A/W	Issue No.	31
LM End	6.38	Issue Type +	Ma	Location *	LS
Category	Supplemental			GPS Latitude/Longitude	
				Start	End
Item	2017 Storm Damage			38.592840 °	38.592390 °
				-121.631340 °	-121.631320 °
DWR ID	DWR_RD2035_02_f_2017_31				
Comment Code					
Inspector Comment					
Levee Evaluation Comments					
Description:					
Site ID No:195					
Site Designation:RD 2035-08					
Repair Type: Erosion					
Rating:Critical					
Field Date:7/13/2017					
Notes: long longitudinal cracks on the crown. Scheduled for repair 2019.

View looking downstream landside of 2017 Storm Damage, sluffing site.
All plastic is remove, sandbags remain, and is NOT scheduled to be repaired in 2017.

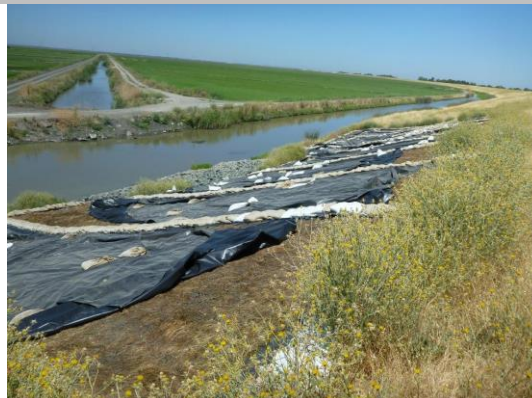
Photo 2 of 4 : LEVAL_FA_2018_195_1600.jpg

LM Start	6.35	Rating **	A/W	Issue No.	31 (cont)	
LM End	6.38	Issue Type +	Ma	Location *	LS	
Category	Supplemental			GPS Latitude/Longitude		
				Start	End	
Item	2017 Storm Damage			38.592840 °	38.592390 °	
				-121.631340 °	-121.631320 °	
DWR ID	DWR_RD2035_02_f_2017_31					
Comment Code						
Inspector Comment						
Levee Evaluation Comments						
Description:						
Site ID No:195						
Site Designation:RD 2035-08						
Repair Type: Erosion						
Rating:Critical						
Field Date:7/13/2017						
Notes: long longitudinal cracks on the crown. Scheduled for repair 2019.

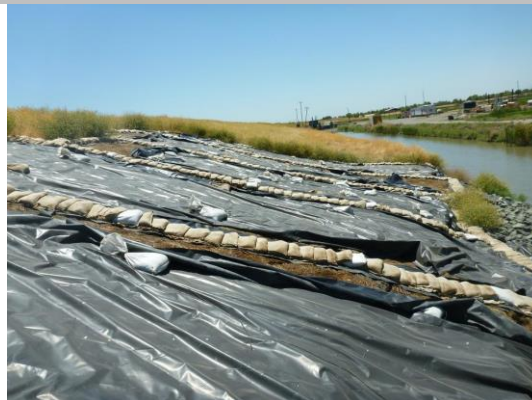
Photo 4 of 4 : LEVAL_FA_2018_195_1592.jpg

LM Start	6.35	Rating **	A/W	Issue No.	31 (cont)	
LM End	6.38	Issue Type +	Ma	Location *	LS	
Category	Supplemental			GPS Latitude/Longitude		
				Start	End	
Item	2017 Storm Damage			38.592840 °	38.592390 °	
				-121.631340 °	-121.631320 °	
DWR ID	DWR_RD2035_02_f_2017_31					
Comment Code						
Inspector Comment						
Levee Evaluation Comments						
Description:						
Site ID No:195						
Site Designation:RD 2035-08						
Repair Type: Erosion						
Rating:Critical						
Field Date:7/13/2017						
Notes: long longitudinal cracks on the crown. Scheduled for repair 2019.

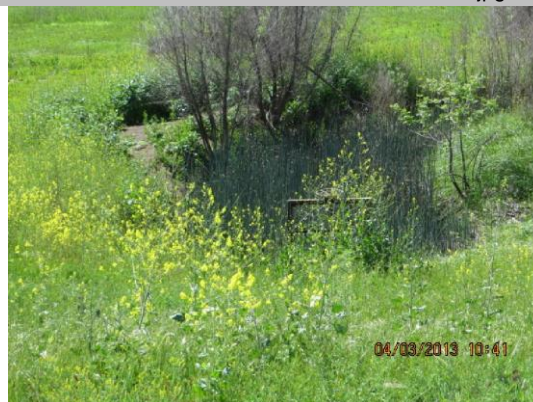
Photo 1 of 2 : UCIP_FA_2018_11011_18354.jpg

LM Start	2.17	Rating **	M	Issue No.	976
LM End	2.17	Issue Type +	Ma	Location *	
Category	Supplemental			GPS Latitude/Longitude	
				Start	End
Item	DWR UCIP LMA Responsibility			38.590934 °	38.590934 °
				-121.658940 °	-121.658940 °
DWR ID	17837				
Comment Code					
Inspector Comment					
FS_ID:11011					
DS_ID:17837					
EP_NO: N/A					
Repair Type: Non-Urgent					
Crossing Status: Found					
UCIP Comments: 04/03/2013 Debris and vegetation partially blocking inlet and outlet at both toes. (W. Wylie - DWR UCIP)					
FIELD_STRUCT_DESC: 48-inch corrugated metal drainage pipe through the levee, 19 feet below the crown. Slide gates on both ends. [Additional Reference(s): DWR Levee Log, 1990. USACE Sacramento O&M Manual 120, June 1952, (Station 290+37)].					
FS Date: 4/3/2013

Slide gate at WS toe showing excessive vegetation.

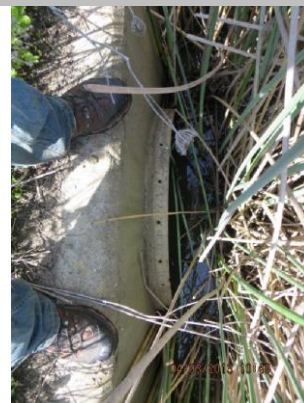
Photo 3 of 3 : UCIP_FA_2018_11012_18355.jpg

Headwall and pipe on LS toe.
